Manhole Inspection Summary

Manhole # S35I__004MH

Insp Date: **8/12/08 12:24 PM**

Location Address: **light st**

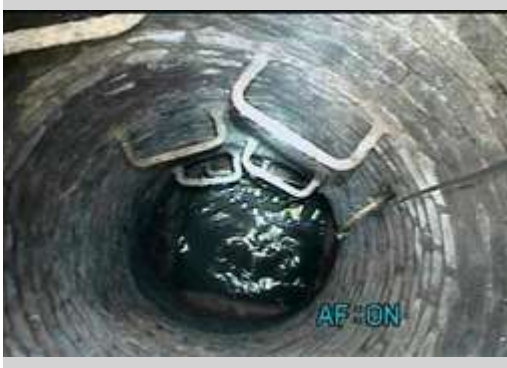
Defect 2

Steps Count: **11** Missing: **1** ☒ **Corroded**

steps

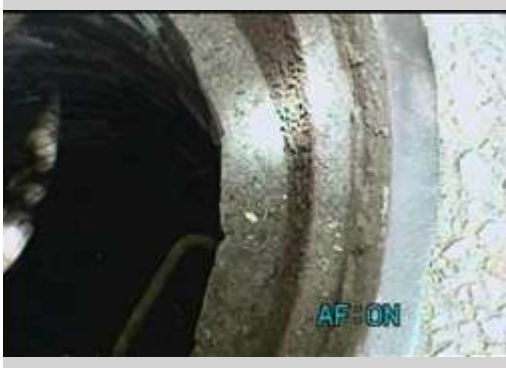
Defect 1

Frame Offset: **2** (in.) Condition: ☒ Sound ☐ Cracked ☐ Leaks

offset

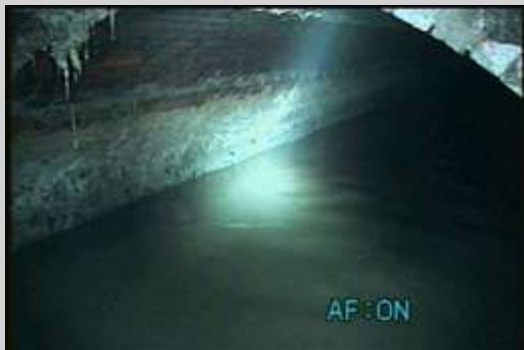
12 O'Clock Outflow

72 in. Circular Gravity Sewer
Pipe Out @ 12 O'Clock

left side of 74" pipe

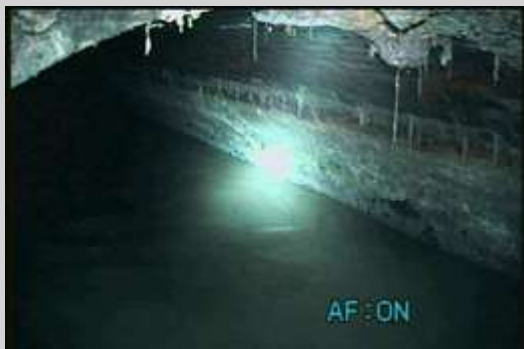
6 O'Clock Inflow

72 in. Circular Gravity Sewer
Pipe In @ 6 O'Clock

right side of 74" pipe at 6

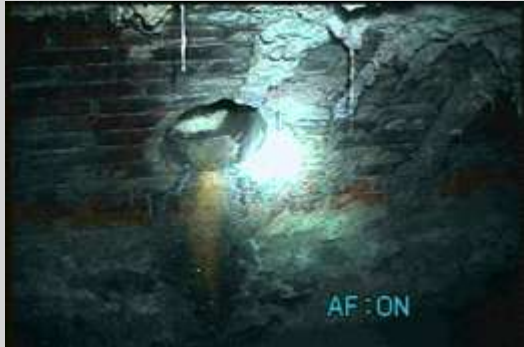
9 O'Clock Inflow

Lateral connection (9 oclock) to 74" pipe.
